Summary Report No. II

DETERMINATION OF CONTAMINATION CHARACTER OF MATERIALS IN SPACE TECHNOLOGY TESTING

CONTRACT NAS5-11697

SRI Project PSU-7907

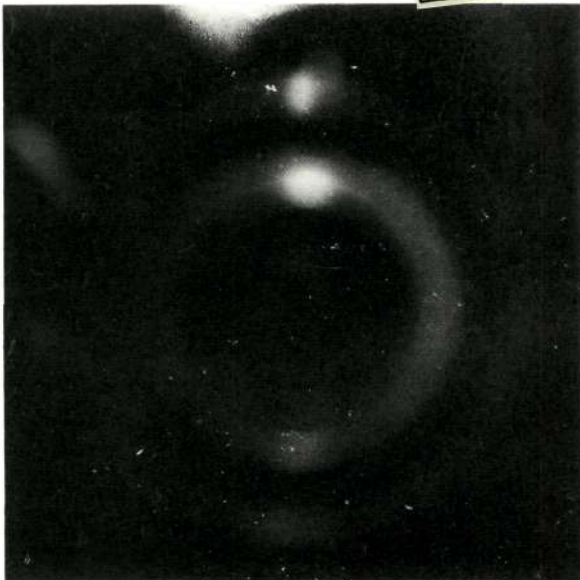
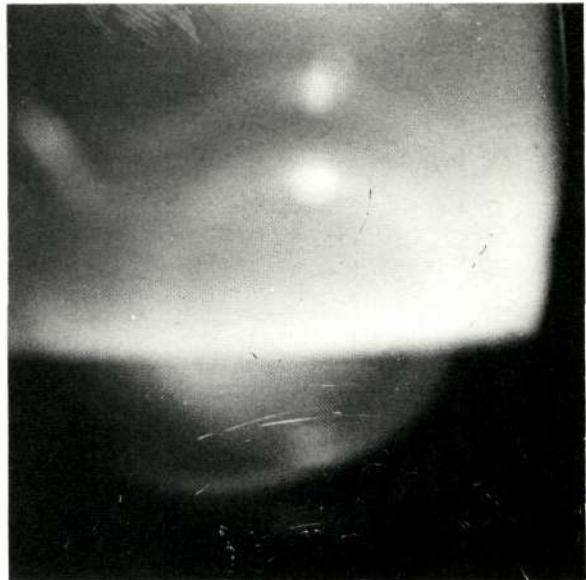
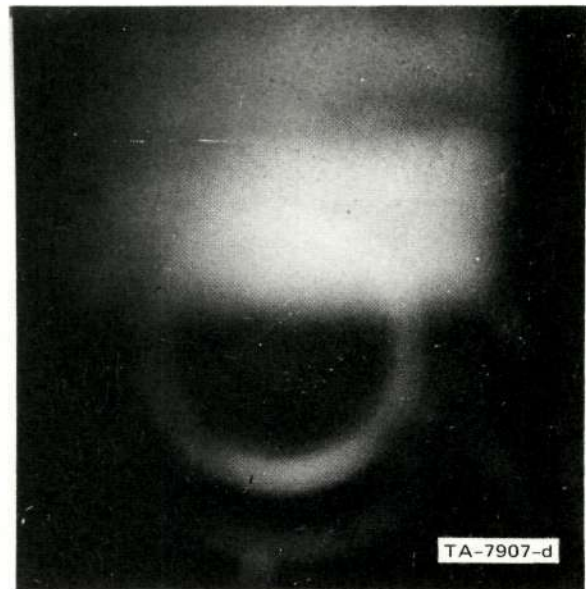
FIGURE 3 MATERIALS SUBJECTED TO THERMAL VACUUM

Photographs of the test mirrors after removing them from the vacuum chamber, given in Figure 3, gave a good permanent record of the visual appearance of the deposits. There is a qualitative agreement between the appearance of these photographs and the other data collected in these studies.
